MANAGEMENT OF INTERNAL ROOT RESORPTION BY PLACING POLYETHYLENE FIBRE - A CASE REPORT

CASE REPORT

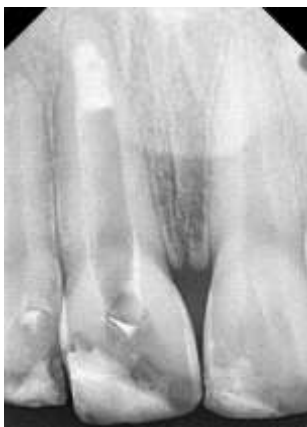
Figure 2: MTA placed at the apical region of root.

At the second appointment, the canal was copiously irrigated with saline and meticulously dried with paper point to prepare it for the next stage of the procedure. A 4 mm thickness of MTA (Mineral Trioxide Aggregate) plug (SafeEndo, root repair material) was placed at the apical region of the root (Fig. 2), to repair the breach caused by the internal root resorption. This step was crucial in reinforcing the structural integrity of the tooth and ensuring a successful outcome of the root canal treatment.

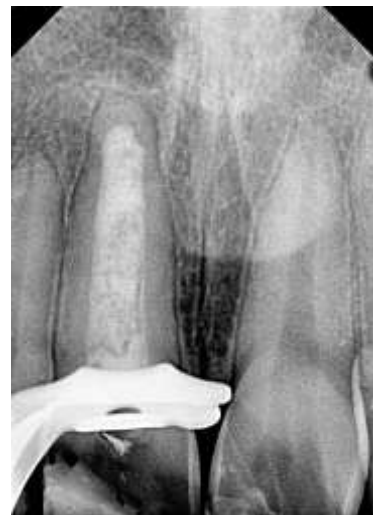
Figure 4: Obturation using Ribbond fibre embedded

in dual cure composite resin.**DISCUSSION**

An appropriate length (2cm) of Ribbond was selected, measuring twice the length of the root space to ensure sufficient coverage (Fig. 3). The Ribbond fiber was then soaked in adhesive resin to thoroughly wet it, and any excess resin was carefully removed using a piece of gauze. The dual-cured resin cement was subsequently injected directly into the root canal. To position the Ribbond within the canal, the mid-point of the wetted Ribbond was draped over the end of a plugger, which was then carefully inserted and pushed into the canal until it reached the apical end of the root space. It was then light-cured (Fig. 4). Access opening space was restored with composite.
