## ENVIRONMENTAL RISK ANALYSIS IN PERTAMINA PIPE INSTALLATION MAINTENANCE REFINERY UNIT IV CILACAP ON KALI YASA RIVER, CENTRAL JAVA INDONESIA

PT Pertamina Refinery Unit IV Cilacap plans to carry out pipeline maintenance on a cross-country track along 5,300 meters. The activities will be carried out in the form of pipe replacement with the aim of increasing the safety of the distribution pipes. Research is a risk analysis study that aims to identify the existence of negative impacts, predict the level of possible emergence of hazards, evaluate risks that may occur and manage risks that may occur due to maintenance activities of crossing oil fuel distribution pipes with Kali Yasa river. **The method** used in this study is the method: American Petroleum Institute (API) 581. This method is a risk assessment method which consists of several stages of assessment are qualitative risk assessment, quantitative risk assessment, and semi quantitative risk assessment. **The results** of the survey and the magnitude of each risk were analyzed and then grouped based on the consequences of the range of risks and the determination of the possibility of the risk of failure from the source of the

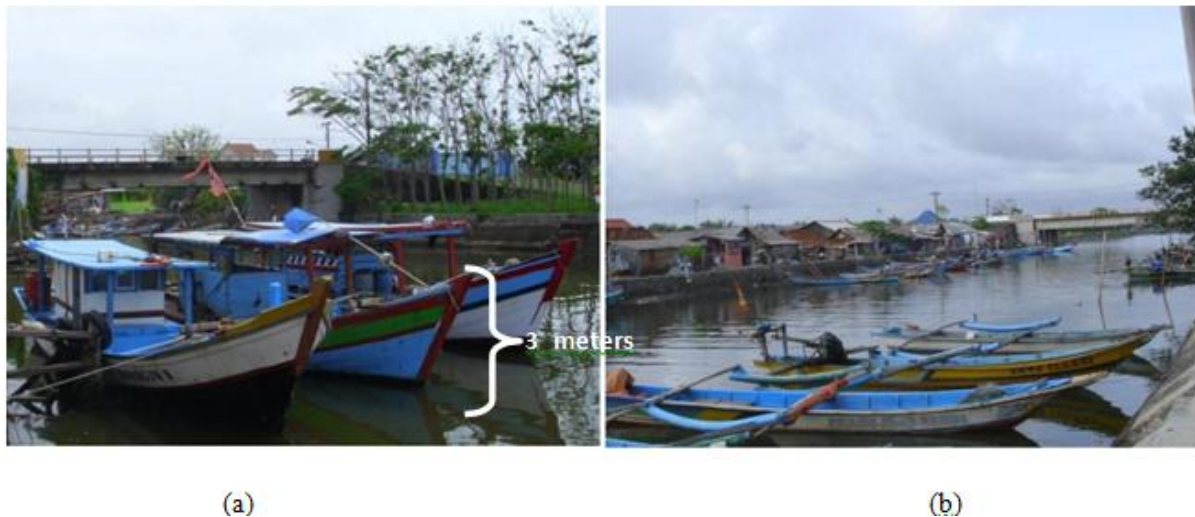
**Figure 2: The ship used by fishermen around Kaliyasa Remarks a). Combrengh ships ship height; 3 meters and b). Fiber Ship.**

The type of vessel used by fishermen around the location of the cross-country pipeline bridge construction activities has a height that is still below the planned height of a cross-country pipe bridge. Types of vessels such as comprengh have a maximum boat height of up to 3 meters from the surface of the water, so ships used by fishing communities around the construction site of cross-country pipelines when crossing the bridge will not cause collisions with pipes. Sail schedule: depart early in the morning at 03.00-06.00 WIB Returns at noon at 13.00-14.00 WIB. The type of vessel used by fishermen around the location of the cross-country pipeline bridge
