## ENVIRONMENTAL RISK ANALYSIS IN PERTAMINA PIPE INSTALLATION MAINTENANCE REFINERY UNIT IV CILACAP ON KALI YASA RIVER, CENTRAL JAVA INDONESIA

Dr. Slamet Isworo<sup>1\*</sup> and Poerna Sri Oetari<sup>2,3</sup>

PT Pertamina Refinery Unit IV Cilacap plans to carry out pipeline maintenance on a cross-country track along 5,300 meters. The activities will be carried out in the form of pipe replacement with the aim of increasing the safety of the distribution pipes. Research is a risk analysis study that aims to identify the existence of negative impacts, predict the level of possible emergence of hazards, evaluate risks that may occur and manage risks that may occur due to maintenance activities of crossing oil fuel distribution pipes with Kali Yasa river. **The method** used in this study is the method: American Petroleum Institute (API) 581. This method is a risk assessment method which consists of several stages of assessment are qualitative risk assessment, quantitative risk assessment, and semi quantitative risk assessment. **The results** of the survey and the magnitude of each risk were analyzed and then grouped based on the consequences of the range of risks and the determinat

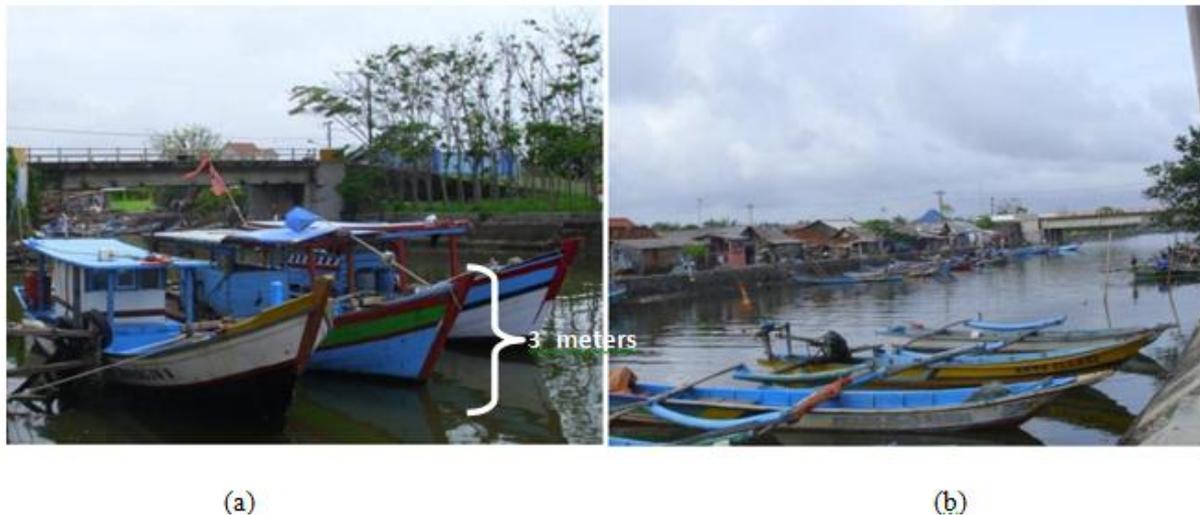
**Figure 2: The ship used by fishermen around Kaliyasa Remarks a). Combrengh ships ship height; 3 meters and b). Fiber Ship.**

The type of vessel used by fishermen around the location of the cross-country pipeline bridge construction activities has a height that is still below the planned height of a cross-country pipe bridge. Types of vessels such as combrengh have a maximum boat height of up to 3 meters from the surface of the water, so ships used by fishing communities around the construction site of cross-country pipelines when crossing the bridge will not cause collisions with pipes. Sail schedule: depart early in the morning at 03.00-06.00 WIB Returns at noon at 13.00-14.00 WIB. The type of vessel used by fishermen around the location of the cross-country pipeline bridge

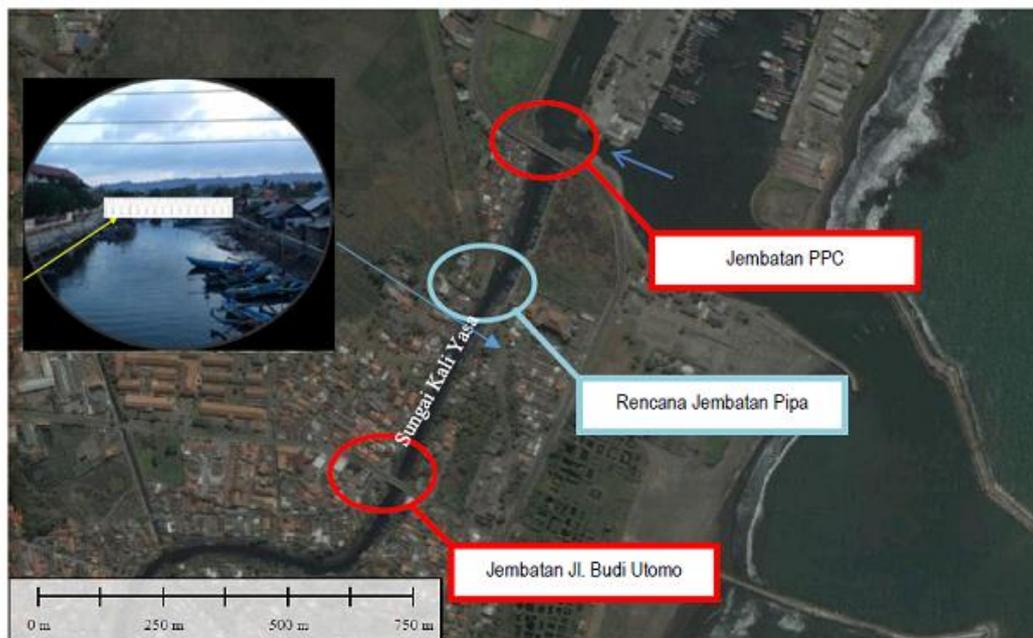
on its position, the pipe bridge that crosses the Kali Yasa River is flanked by two road bridges, namely the PPC road bridge located  $\pm 315$  m north of the pipe bridge and the bridge which is located  $\pm 400$  m south of the pipe bridge as shown in Figure 3, as follows.

**Figure 3: Location of Pertamina pipeline bridge.**

Lokasi jembatan berada di atas sungai Kaliyasa, Cilacap, Jawa Tengah yang berfungsi Fungsi dibangunnya jembatan pipa Kaliyasa adalah untuk menghindarkan jaringan pipa milik PT. Pertamina sehingga tidak mengganggu aliran sungai, lalu lintas Kapal dan tidak mengganggu aktifitas Masyarakat sekitarnya
